An Ohio University Benefits from New Technology and Innovation to Recreate a Historic Cupola

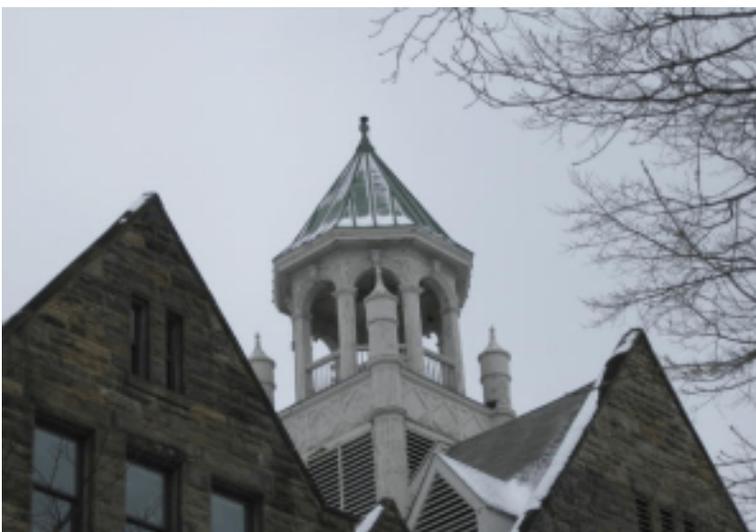
When the cupola's paint started to peel, crews discovered the tower's cladding was deteriorating.
PHOTO: Bill Perry
