An Ohio University Benefits from New Technology and Innovation to Recreate a Historic Cupola

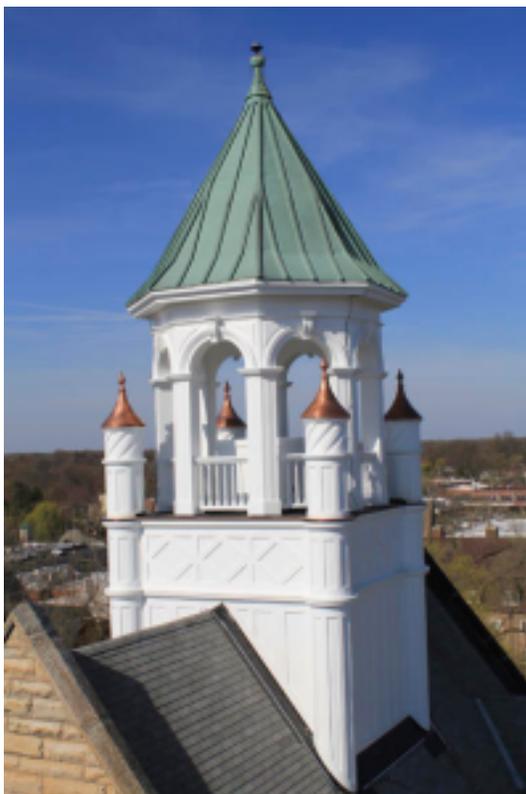
To obtain the profile of the original mouldings, some of the PVC versions are a combination of four or five different sheets put together and then turned down. Custom-ground knives were made for the moulder to match the profiles before the pieces were sent through the CNC machine. PHOTO: Versatex

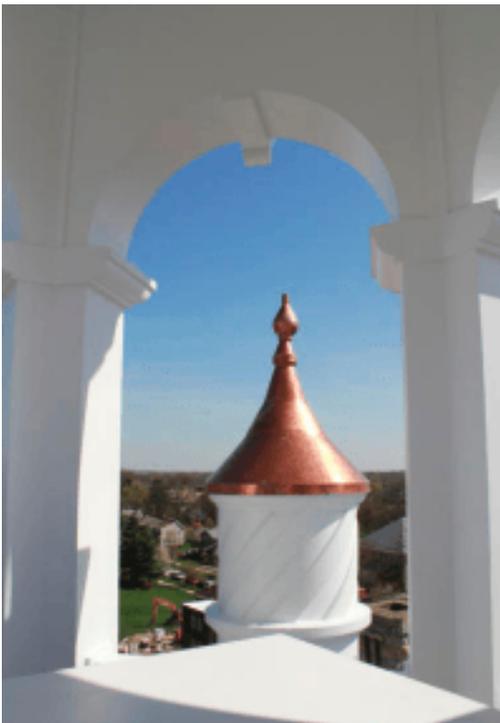
Even with the help of machines, the detailed millwork took approximately 1,100 man-hours.
PHOTO: Versatex

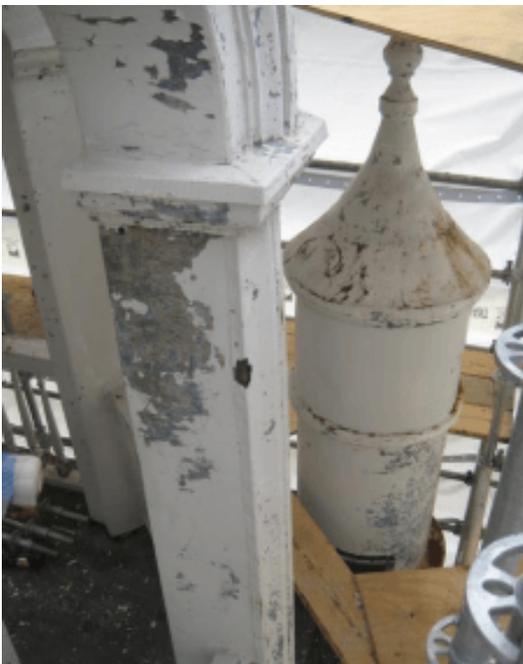
Accurate drawings were critical for proper duplication. Many pieces were painstakingly hand drawn in AutoCAD and sent to the CNC router. PHOTO: Bill Perry
